Intel® Mobile Celeron™ Processor Specification Update

Release Date: July 1999

Order Number: 244444-006

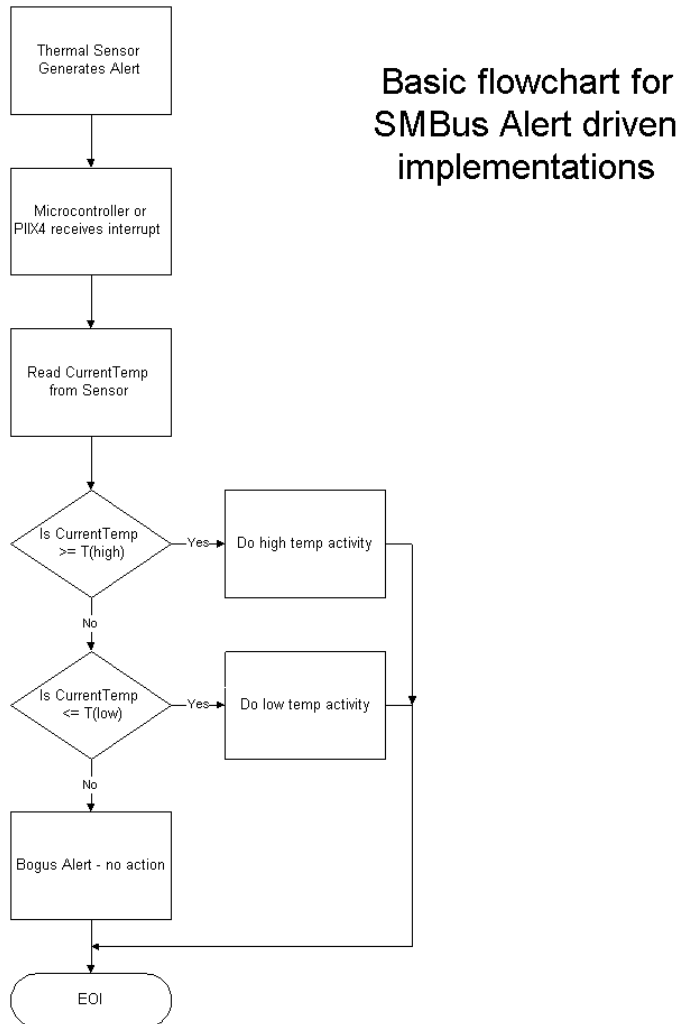
Figure 2. Workaround Flowchart: SMBALERT#-Driven System

PROBLEM: The Intel Celeron Processor Mobile Module has a thermal sensor that monitors the processor core's temperature. Please note that desktop systems could have a similar thermal device. The thermal sensor asserts SMBALERT# if the processor temperature exceeds the temperature limits set in the Alarm Threshold Registers (T_{HIGH} , T_{LOW}). It also sets the corresponding Status Register bits to identify the cause of the interrupt. Figure 1 gives one example of the how the SMBALERT# signal could be used in a system.

Under the conditions described below, the thermal sensor incorrectly generates the SMBALERT# interrupt. *All* of the following conditions must be met to trigger a false interrupt:

WORKAROUND: Three different (mutually exclusive) workarounds are possible:

1. Before servicing an interrupt from the thermal sensor, read and compare the processor thermal reading with the threshold limits (T_{HIGH} or T_{LOW}). Figures 2 and 3 provide basic flowcharts for the implementation of this workaround in an interrupt driven system.
2. If the firmware implemented polls the Status Register only, then before taking any action, re-read the temperature register and do a comparison with the alarm threshold limits (T_{HIGH} or T_{LOW}) to determine if the value is actually still within the temperature window.
3. Use a temperature polling scheme to monitor the processor temperature.

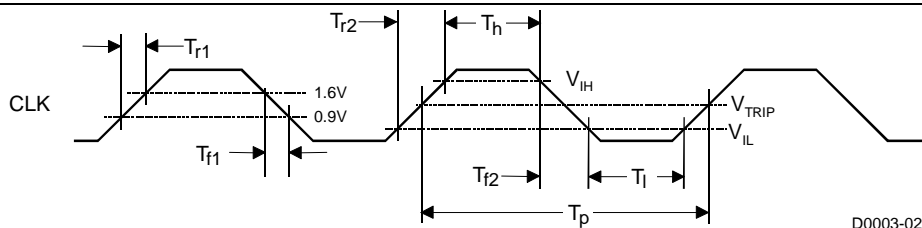
H11. Generic Clock Waveform Figure

Figure 3.3 in the *Intel® Mobile Celeron™ Processor in μ PGA1 and BGA1 Packages at 366 MHz, 333 MHz, 300 MHz, and 266 MHz* datasheet (Order Number 245112-003) has been updated. The following figure is to replace the one in the above document.
